City of Chewelah

Civic Center Improvements

The Civic Center

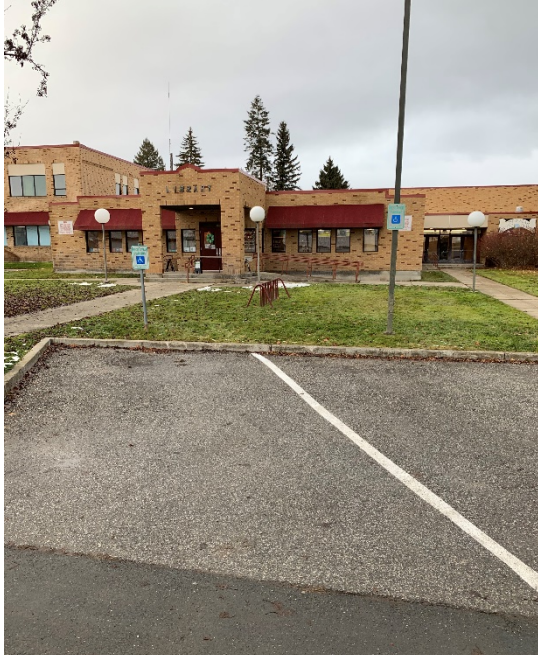
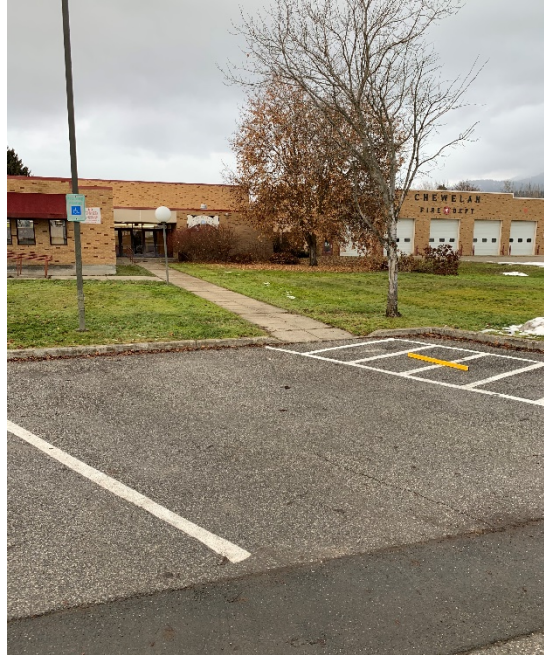
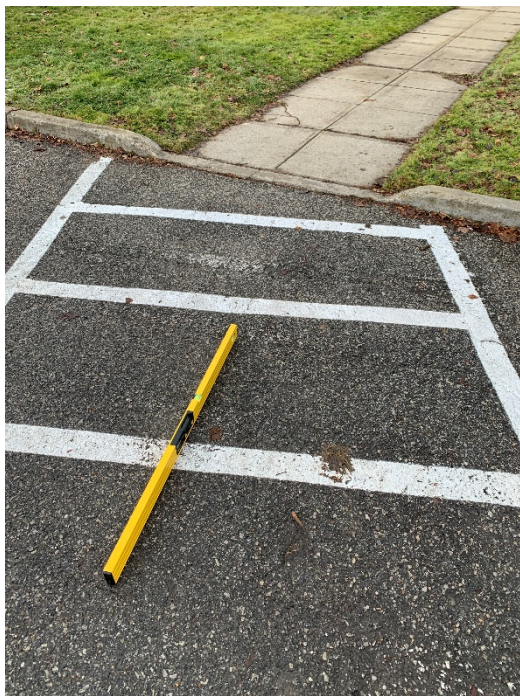
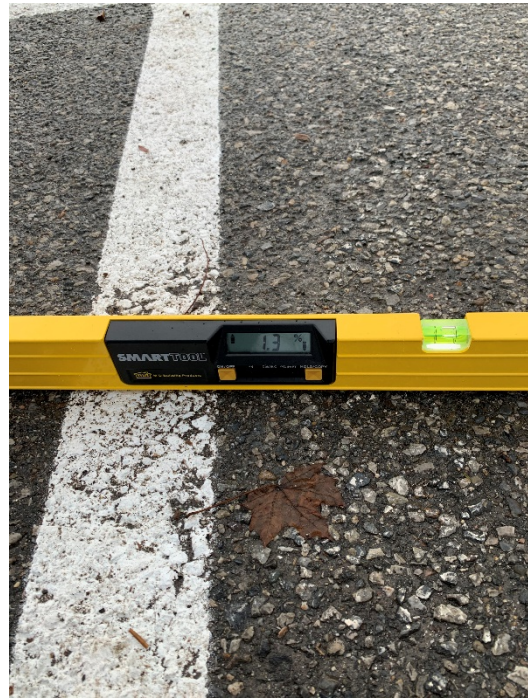
1. Figures 1-4 show the ADA Parking stalls at southern building entrance. Both stalls appear to be less than 2 percent slope in all directions as shown in Figure 4 and therefore meet the accessibility slope requirements.

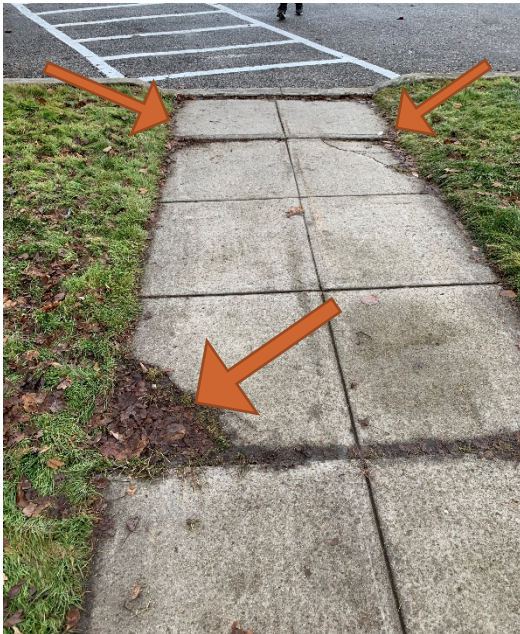
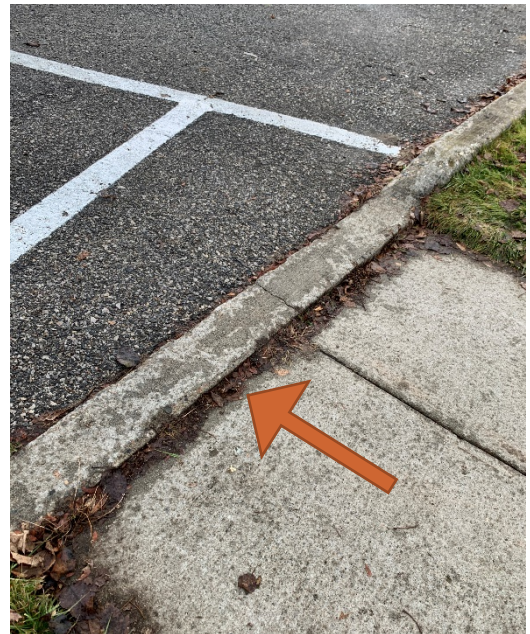
2. ADA guidelines require a maximum discontinuity in vertical surfaces to be $\frac{1}{2}$ inch. Figures 5 and 6 below show areas of concern marked on the southern ADA entrance. These panels should be sawcut at the joints, removed and replaced with new concrete. Approximate cost: \$1,500 - \$2,500

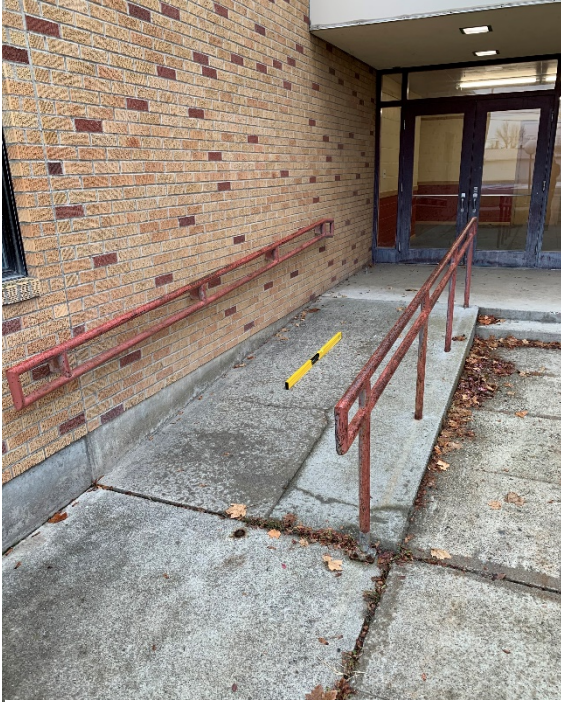
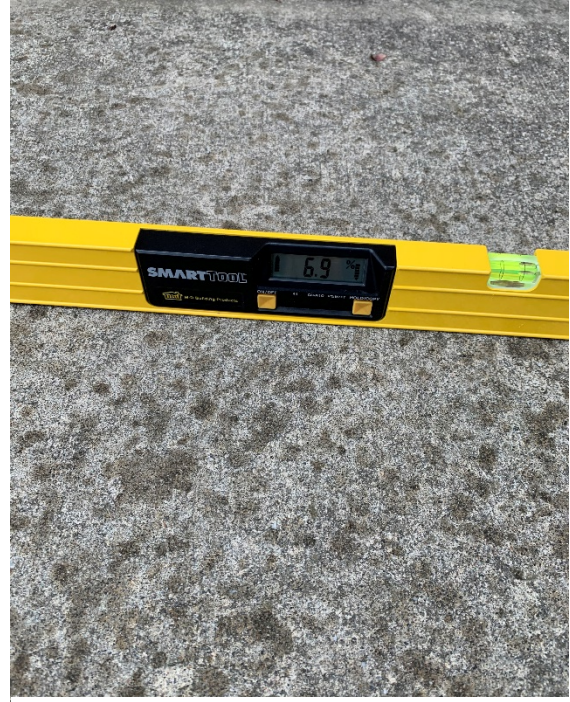
3. The ramp at the southern entrance appears to meet accessibility requirements.

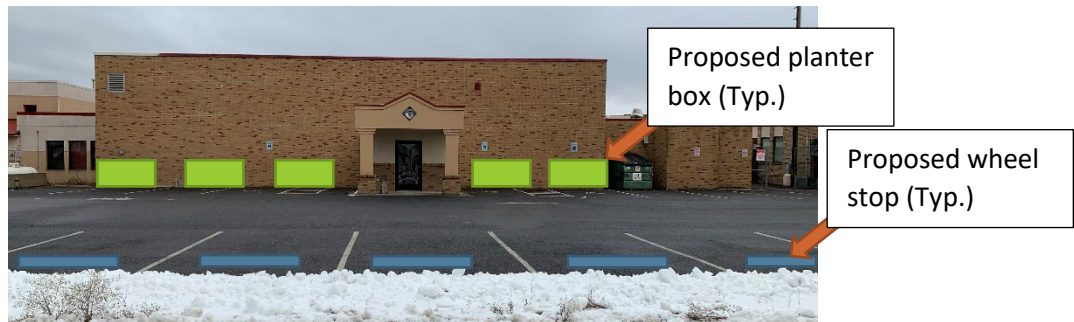
Figure 9

4. Adding wheel stops along the northern side of the building will add protection from vehicles pulling too close to the building and causing potential damage. Also, the addition of a vegetated strip along the building, or planters, may also help address this concern as well as beautification to the building. It is also recommended that wheel stops be added along the planter strip on the north edge of the parking lot. Approximate cost of wheel stops: \$150 - \$200 per wheel stop. Cost of Planters: \$2,500 - \$5,000

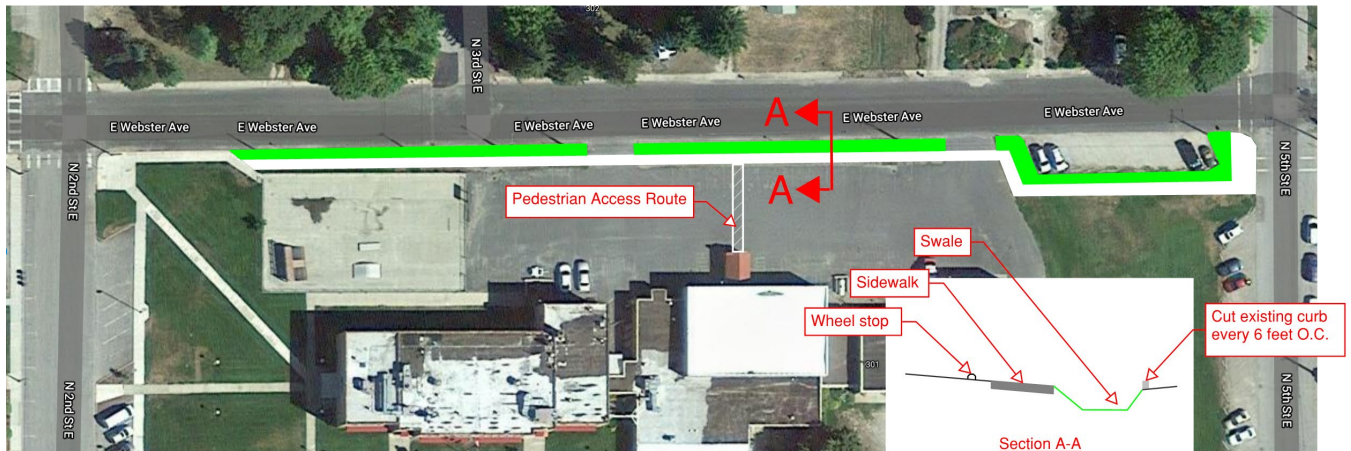
5. Accessibility to the site from E Webster Ave is not currently provided as there is no sidewalk on the southern side of the street from N 2nd Street E to N 5th Street E. It is recommended that a sidewalk be added along with a pedestrian pathway to the northern building entrance per Figure 10 below. Stormwater runoff from the northern parking lot currently sheet flows to the north into a grass depression. Once a sidewalk is added, it is recommended a swale be added between the sidewalk and curbing to provide water quality treatment for the stormwater runoff of both the road and parking lot. See Section A-A on Figure 10. Approximate cost of improvements: \$50,000 - \$75,000

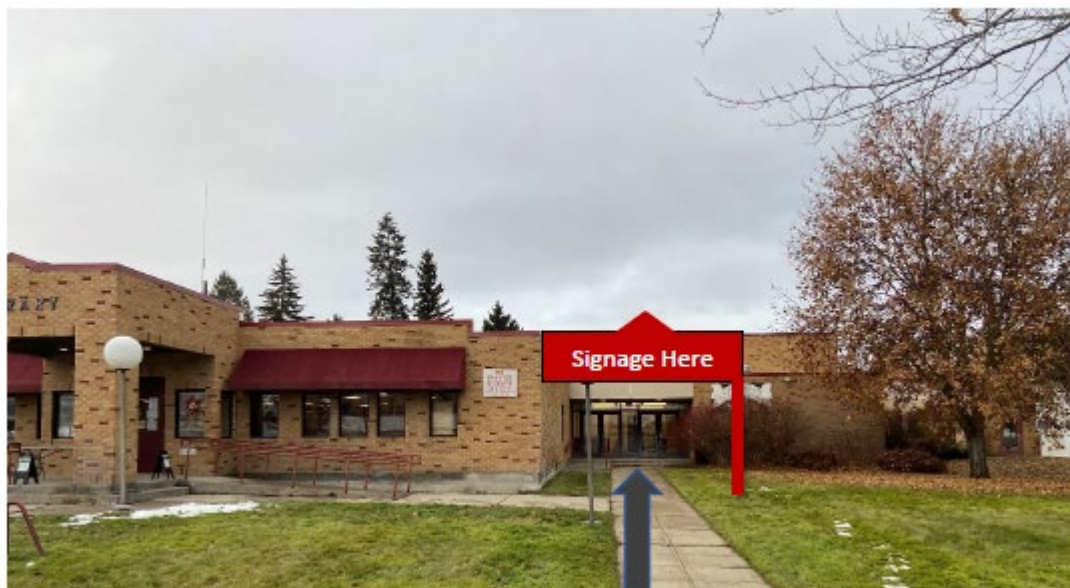
Figure 1

The recessed entry process of the civic center could be improved with an “arbor” referencing the forms of the rest of the building, perhaps timber, like the bell structure, that could make the entry more prominent and provide opportunities for signage and more visibility. See example massing in *figure 1*. Additional exterior lighting is also recommended. The ROM in terms of cost for this suggestion is between \$10K-\$40K.

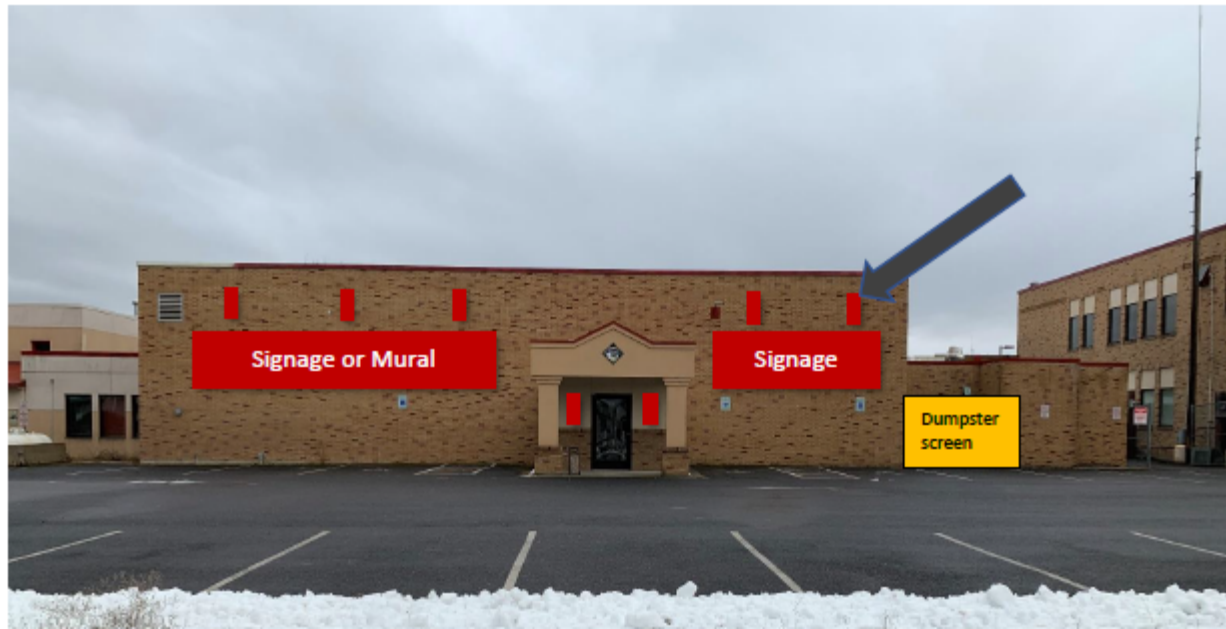
Figure 2

The friendliness and entry process on the back entry of the civil center could be improved by adding exterior lighting or sconces to the building, with exposed conduit to preserve the brick and signage or a potential mural. Additionally a dumpster screen/gate would approve aesthetics. The ROM in terms of cost for this suggestion is between \$10K-\$30K.

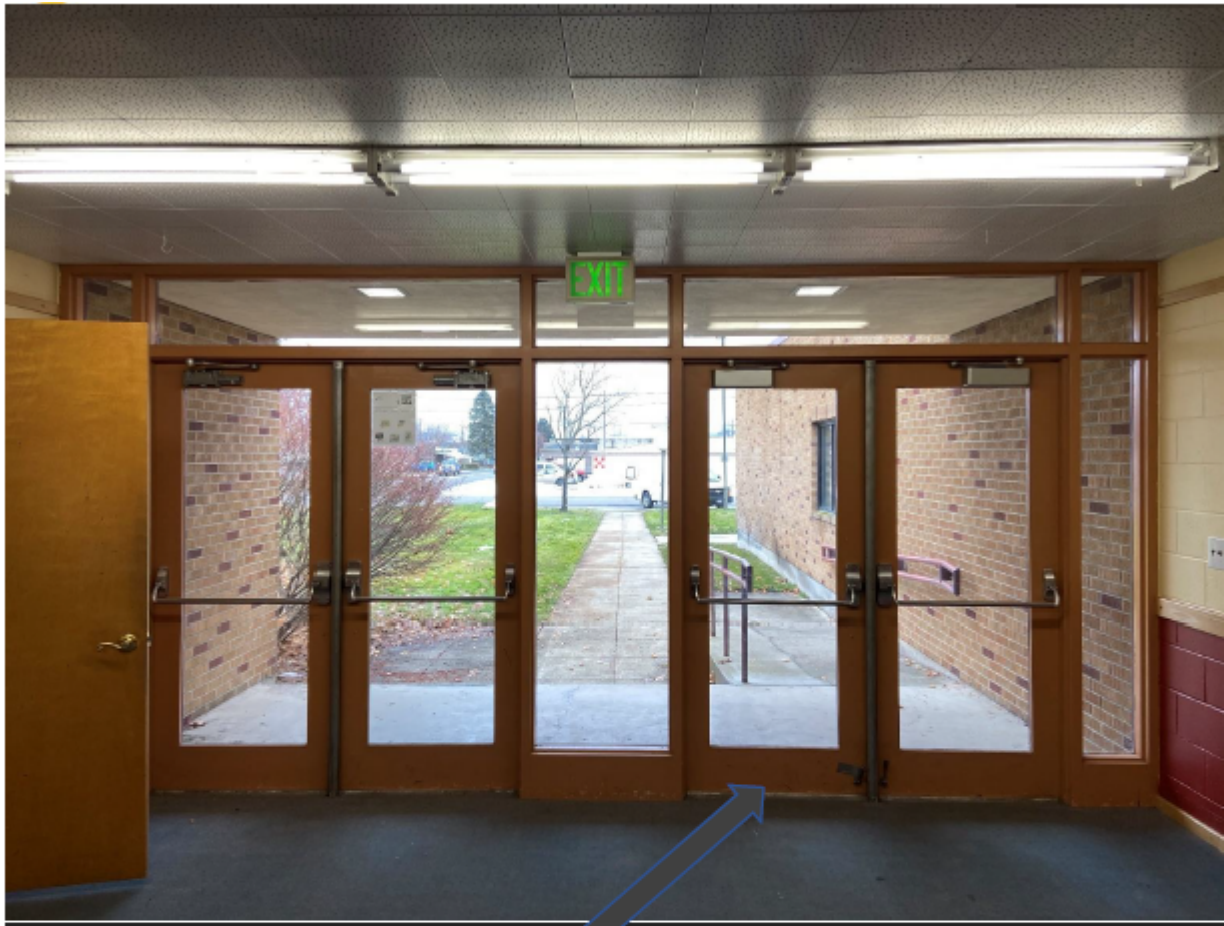
Figure 3

The condition of the storefront front and back entry of the civic center is in relatively good shape from the interior with visible fading and ageing from the exterior. Painting of the storefront and inside and out is recommended, if not replacement. The ROM in terms of cost for this suggestion is between \$1K-\$15K. ADA accessibility and door thresholds appear to be in compliance. Tactile exit sign must be added for ADA compliance.

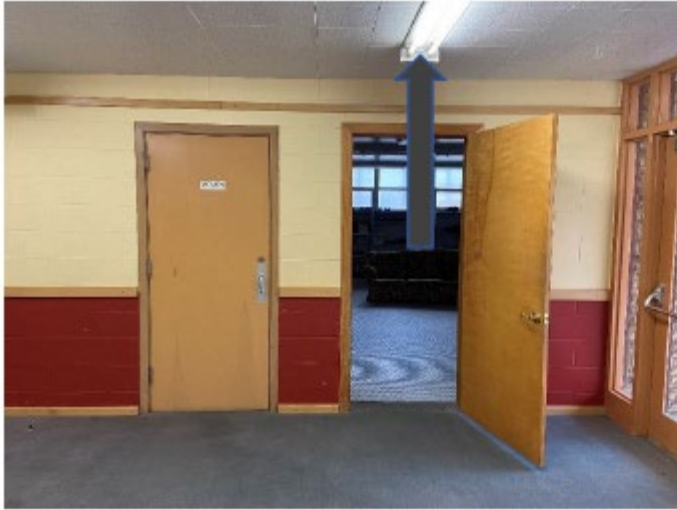
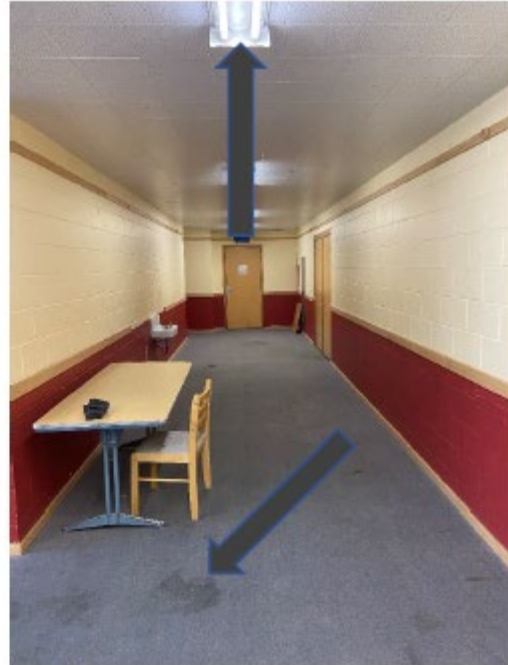
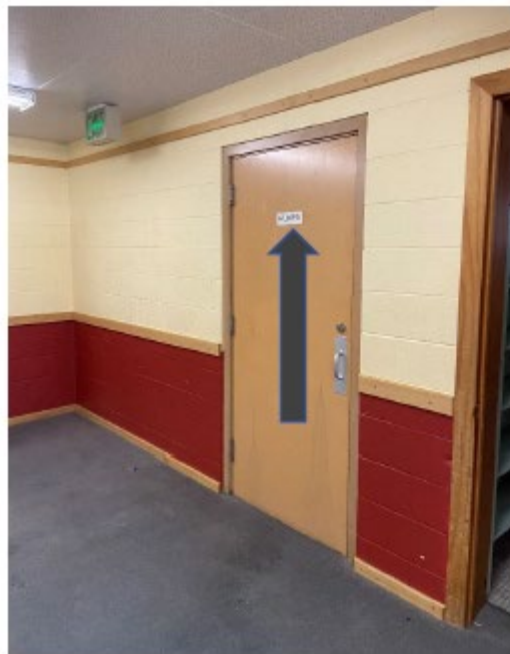
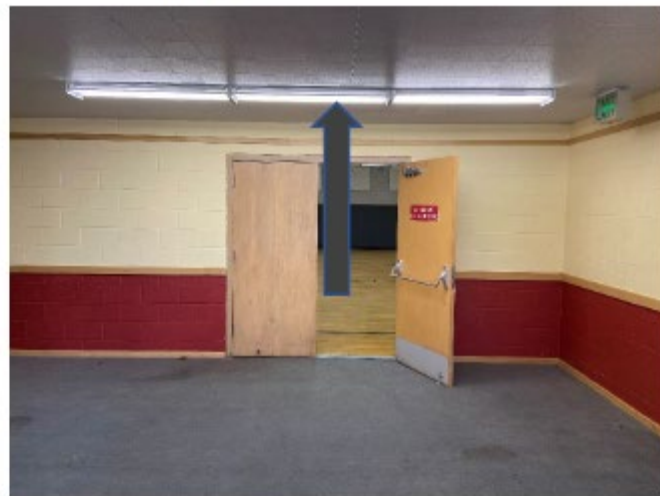
In figures 3-7 show the condition of the lobby. It is recommended the ceiling tiles be replaced, and warmer recessed led lighting be added in the ceiling tiles. The carpet should be replaced, carpet tiles are recommended for acoustics, maintenance, cost and longevity. It is recommended this space in its entirety be painted a lighter color with a durable low VOC paint, consider removing or painting the existing wooden chair rails an accent color. It is recommended that all the interior doors and hardware be replaced with durable and ADA compliant selections. All bathroom signage needs to be brought up to ADA standards. The drinking fountain needs to be brought up to ADA compliance below in figure 8. The ROM in terms of cost for this suggestion is between \$30K-\$100K.

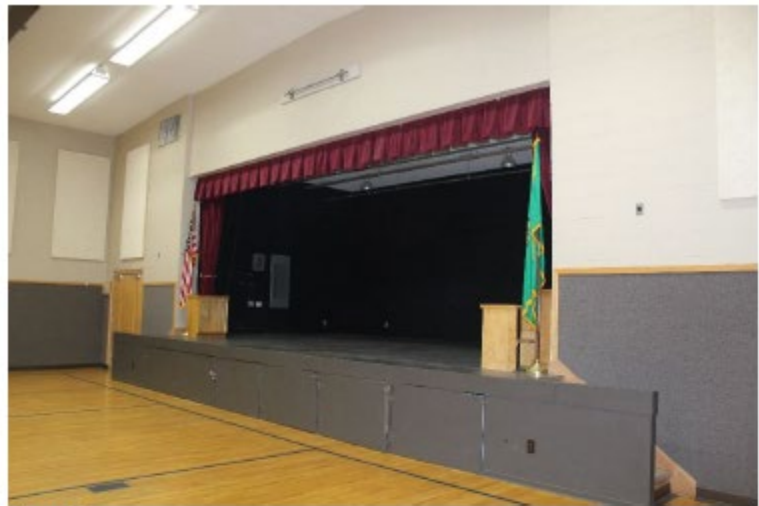
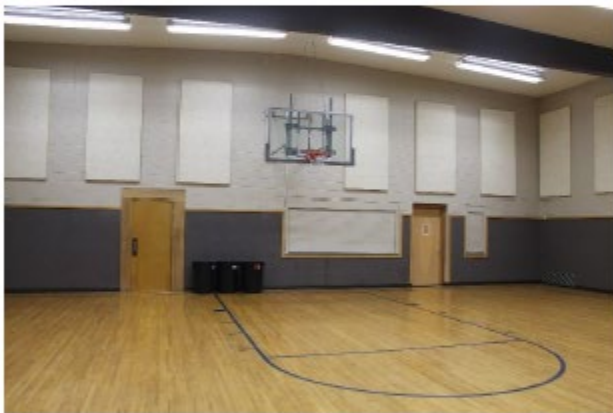
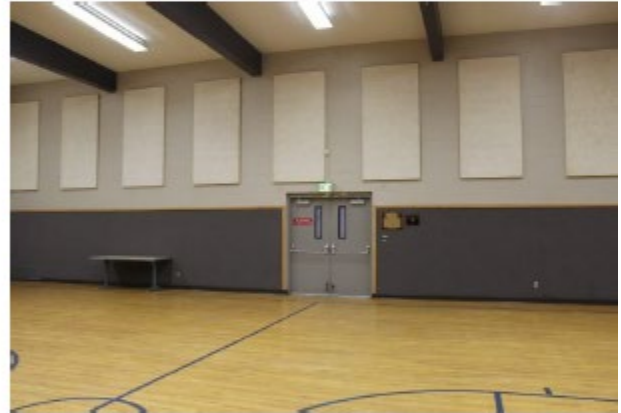
Figures 9-11 are of the gymnasium and stage. These spaces are in relatively good condition. It is recommended to make the stage ADA accessible with a modular metal ramp or a wheelchair lift to be purchased and stored when not in use. See example ramp in figure 12. The ROM in terms of cost for this suggestion is between \$3K-\$7K.

It is suggested for the gymnasium in *figures 9-11* that the existing wall carpet be replaced with a wipeable surface, if not then consider carpet tiles for a fresh aesthetic and the ability to individually replace them as they get damaged. Consider painting the acoustic panels and the wall the same color and painting the stage. The ROM in terms of cost for this suggestion is between \$10K-\$25K.

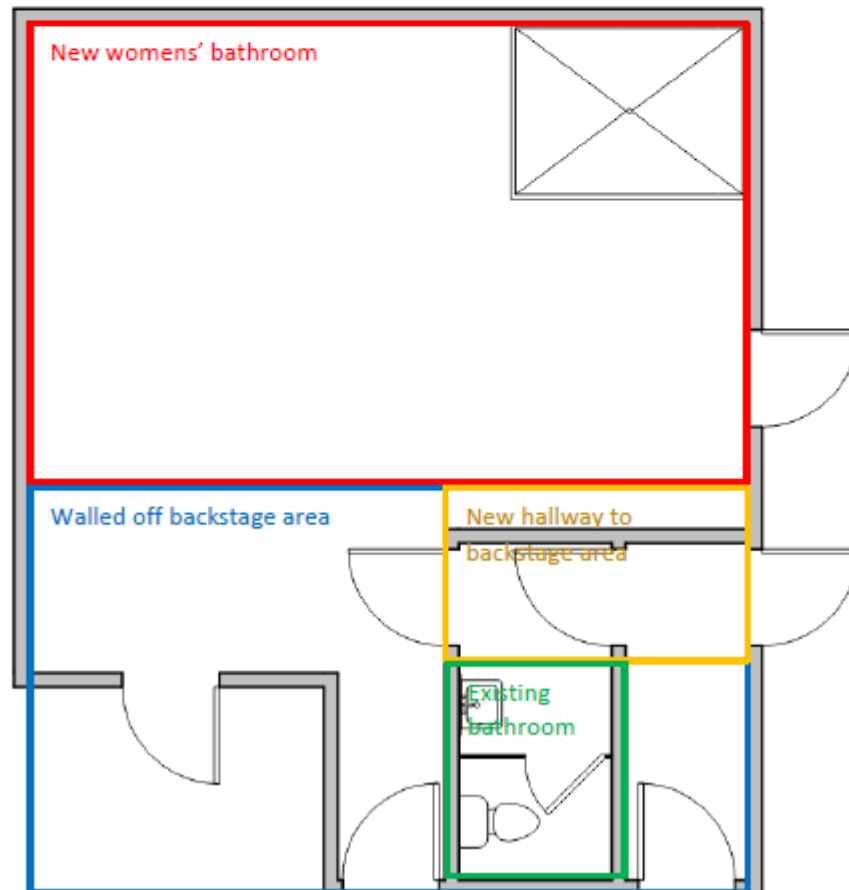
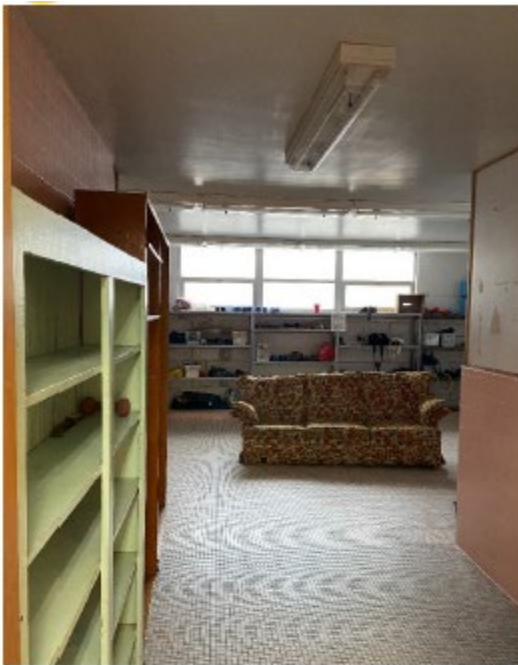
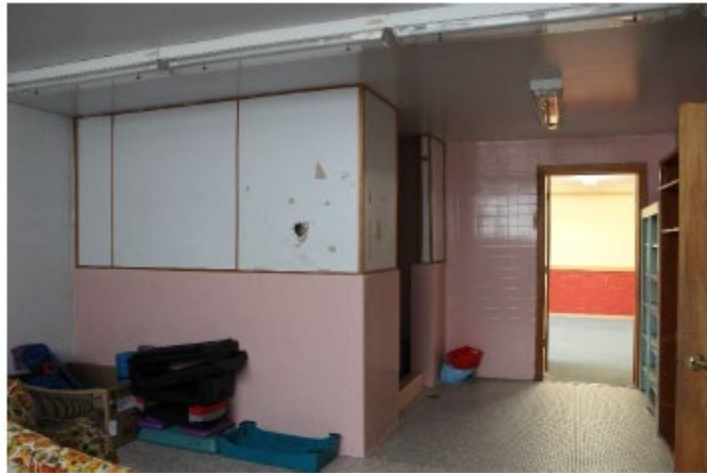
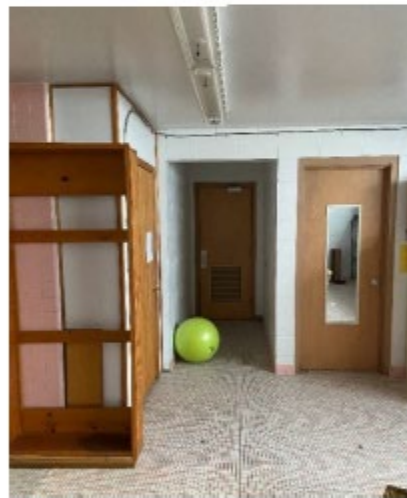
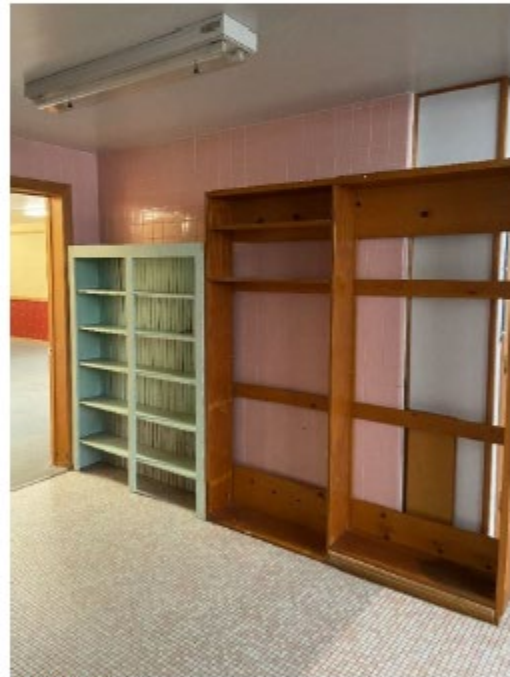
Figures 13-17 show the gymnasium's original girls' locker and bathroom spaces. The asbuilt diagram is for broad planning purposes and needs to be field verified before any architectural work commences. It is suggested that completely renovated, modern bathrooms meeting ADA standards be designed and constructed in this existing space, the area in red. Full architectural services will be required for this scope of work including an in depth code review, in the absence of more information it is anticipated two stalls, one of which is ADA compliant will be required per gender of bathroom. The ROM in terms of cost for this suggestion is between \$50K-\$80K.

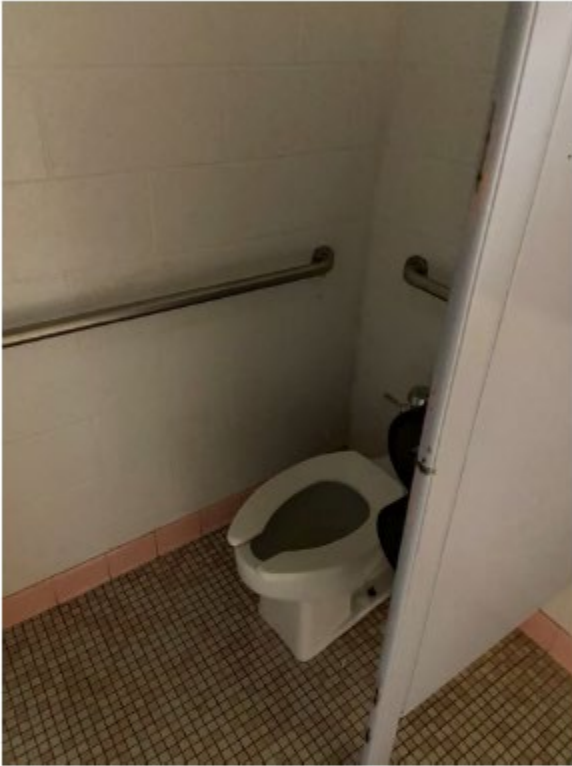
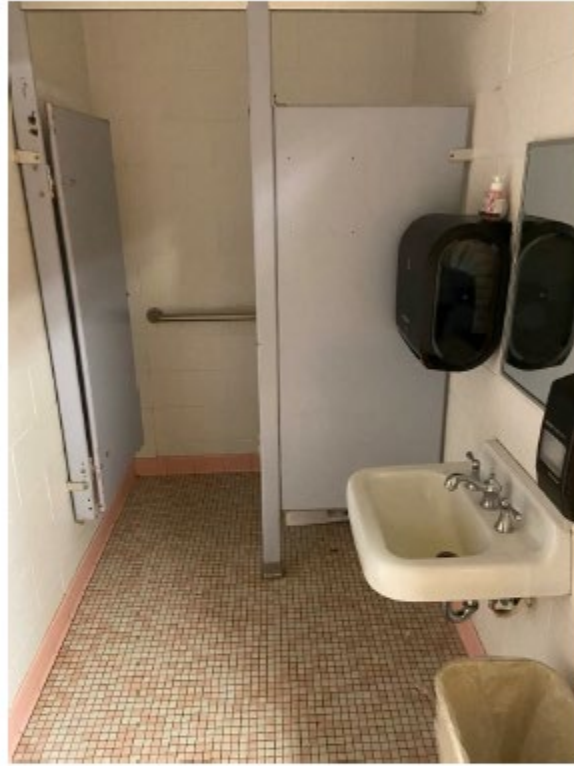
Figures 17-18 show existing women's bathroom. It is suggested that the existing bathrooms stall space could stay relatively in tact and be walled off to the backstage area with a new hallway for performance purposes, the areas in green blue and yellow. A cosmetic renovation to modernize it should also be considered. The ROM in terms of cost for this suggestion is between \$15-\$25K.

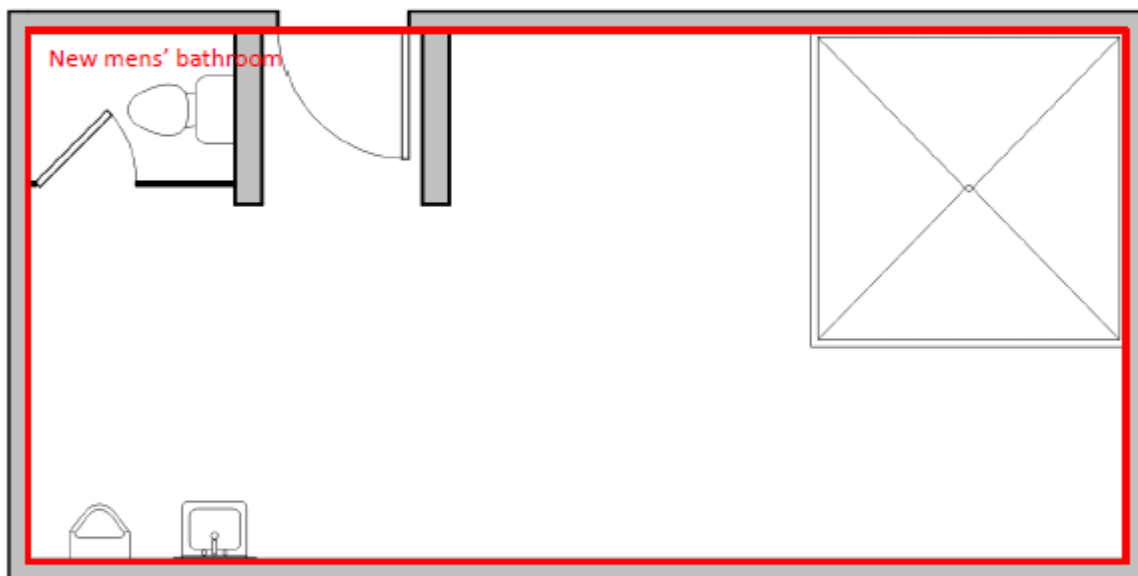
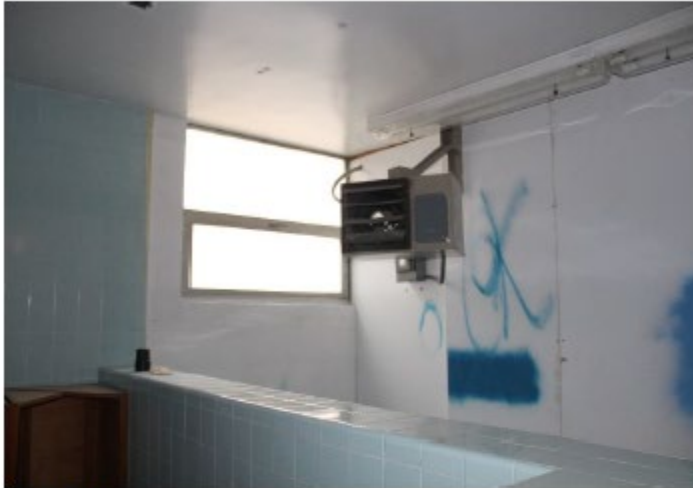
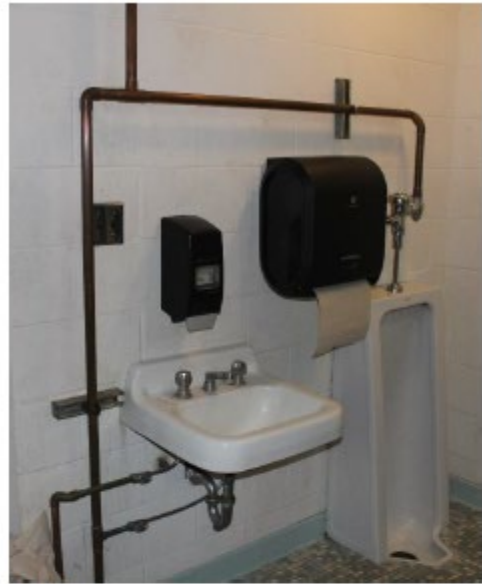
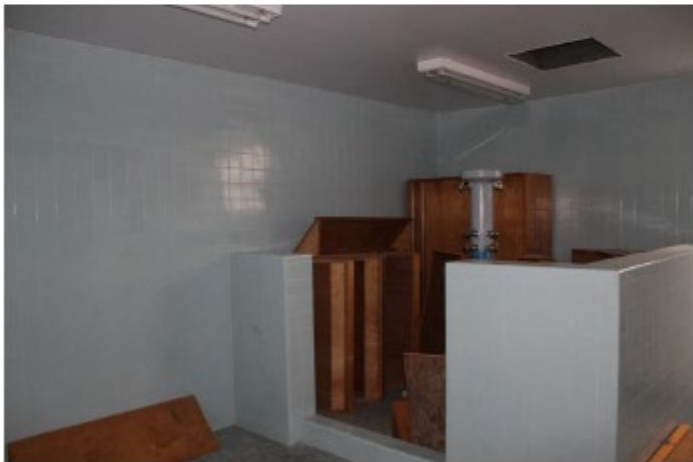
Figures 19-22 show the gymnasium's original boys' locker and bathroom spaces. The asbuilt diagram is for broad planning purposes and needs to be field verified before any architectural work commences. It is suggested that completely renovated, modern bathrooms meeting ADA standards be designed and constructed in this existing space. Full architectural services will be required for this scope of work including an in depth code review, in the absence of more information it is anticipated two stalls, one of which is ADA compliant will be required per gender of bathroom. It is also suggested the mens' bathroom access be relocated to the existing closed off opening located in the lobby hall, for ADA and general bathroom access to be consistent for both genders from the lobby. The ROM in terms of cost for this suggestion is between \$50K-\$80K.

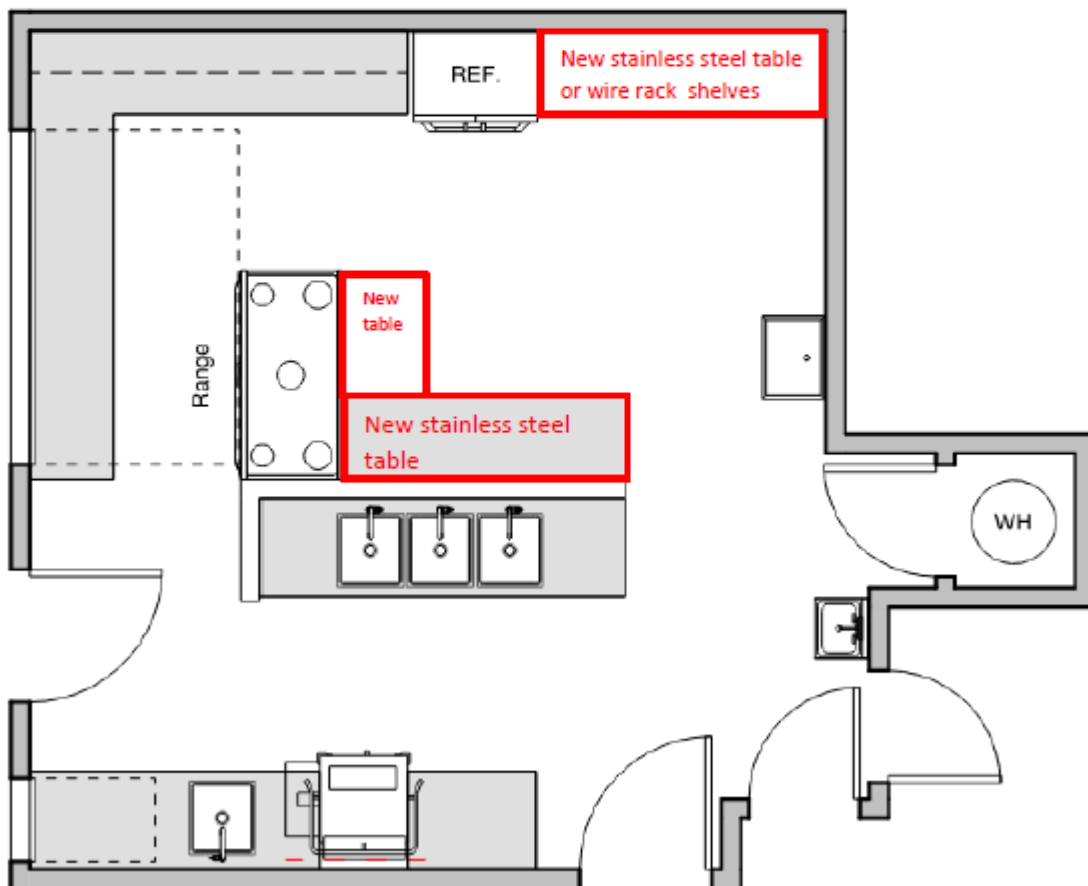
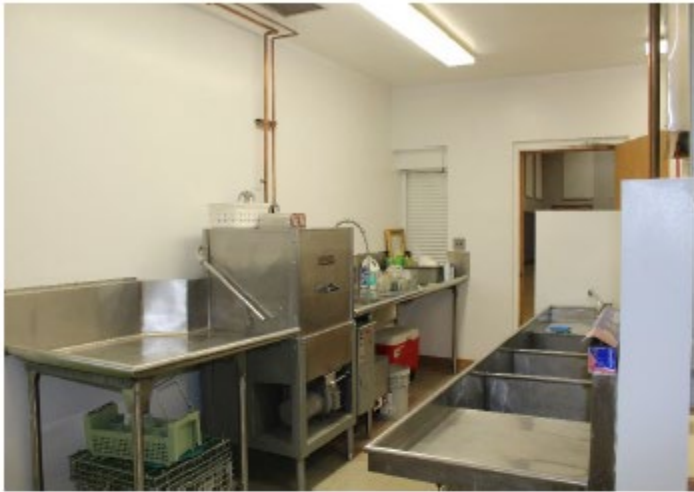
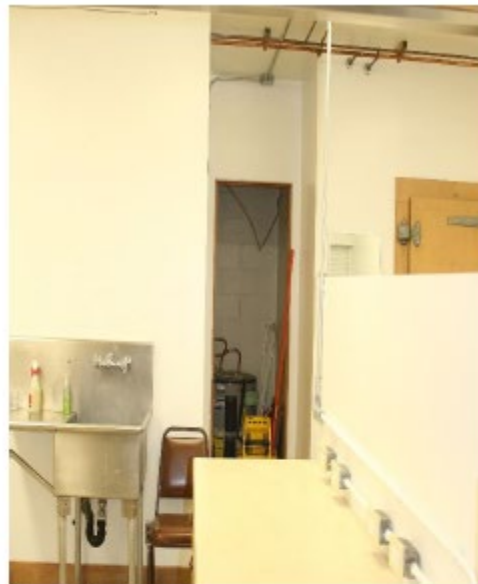
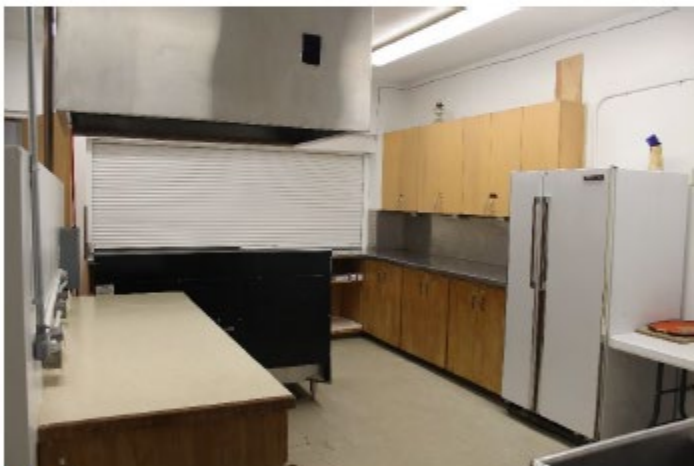
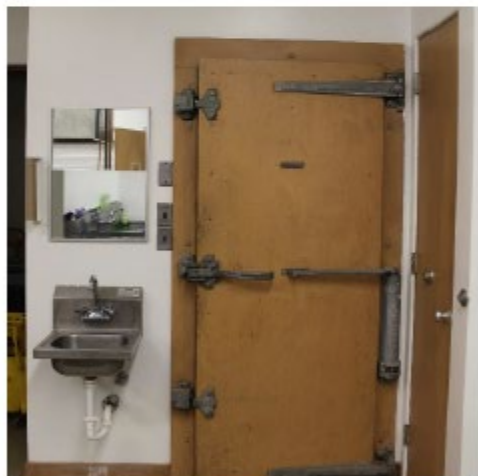
Figures 23-27 show the commercial kitchen adjacent to the gymnasium space. The asbuilt diagram is for broad planning purposes and needs to be field verified before any architectural work commences. Generally, the kitchen is in good condition. It is suggested that the backsplash areas and the half wall perpendicular to the range be wrapped in a wipeable surface such as fiberglass reinforced panels (FRP), remove the cabinetry on the half wall and replace with a stainless steel table, also consider putting one parallel and against the cooktop, and one next to the fridge. It is suggested the remaining existing cabinetry be painted with a high gloss wipeable paint, replace the hardware, replace the flooring, paint the walls and ceiling, replace the fridge. It is also suggested to have the health department inspect and provide compliance guidance. The ROM in terms of cost for this suggestion is between \$15K-\$30K.
